**Flood Control Project Maintenance  
Levee Inspections**

## Maintenance Issue Types Only, Levee Inspection Report By Mile - Fall 2016

### Merced Streams Group

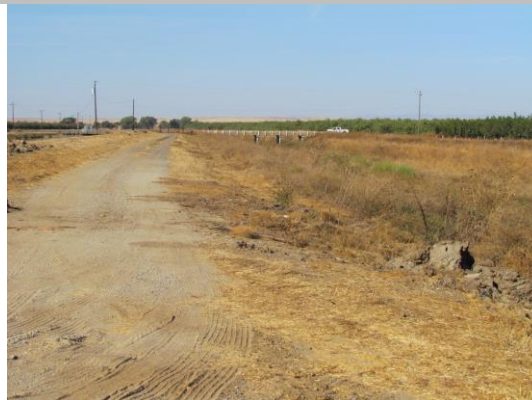
Photo 1 of 1 : FA\_2016\_NA0013\_331\_1\_20161012\_00001.jpg

LM Start	0.00	Rating **	A	Issue No.	1	
LM End	1.27	Issue Type +	Ma	Location *	WS	
Category	Earthen Levee			GPS Latitude/Longitude		
				Start		End
Item	Vegetation			37.314708 °		37.332582 °
				-120.396403 °		-120.394752 °
DWR ID	DWR_NA0013_01_f_2016_1					
Comment Code						
V1 : Control annual grass and weeds on the levee slopes and easements.						
Inspector Comment						
No unwanted vegetation.

NA0013 Merced Streams Group Unit 1 levee mile 0.00.

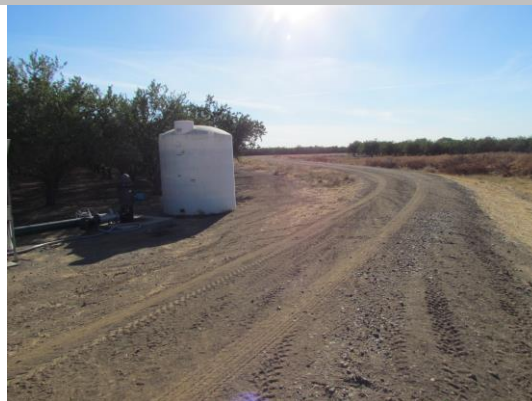
Photo 1 of 1 : FA\_2016\_NA0013\_332\_7\_20161012\_00019.jpg

LM Start	0.01	Rating **	A	Issue No.	7
LM End	1.85	Issue Type +	Ma	Location *	LS
Category	Earthen Levee			GPS Latitude/Longitude	
				Start	End
Item	Vegetation			37.337027°	37.314620°
				-120.387473°	-120.395820°
DWR ID	DWR_NA0013_02_f_2016_7				
Comment Code					
V1 : Control annual grass and weeds on the levee slopes and easements.					
Inspector Comment					
No unwanted vegation.

Unit 2 looking downstream landside slope levee mile 0.00.

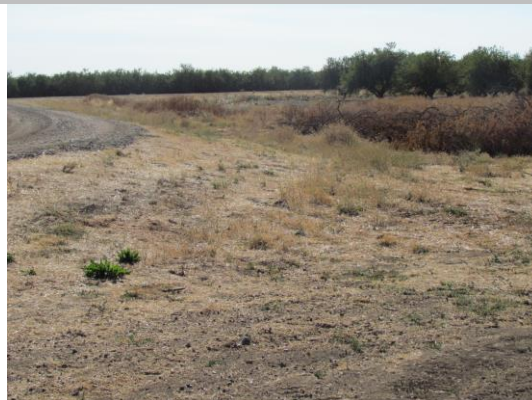
Photo 1 of 1 : FA\_2016\_NA0013\_332\_8\_20161012\_00018.jpg

LM Start	0.01	Rating **	A	Issue No.	8
LM End	1.85	Issue Type +	Ma	Location *	WS
Category	Earthen Levee			GPS Latitude/Longitude	
				Start	End
Item	Vegetation			37.337027 °	37.314620 °
				-120.387473 °	-120.395820 °
DWR ID	DWR_NA0013_02_f_2016_8				
Comment Code					
V1 : Control annual grass and weeds on the levee slopes and easements.					
Inspector Comment					
No unwanted vegetation.

Unit 2 levee mile 0.00 waterside slope looking downstream.

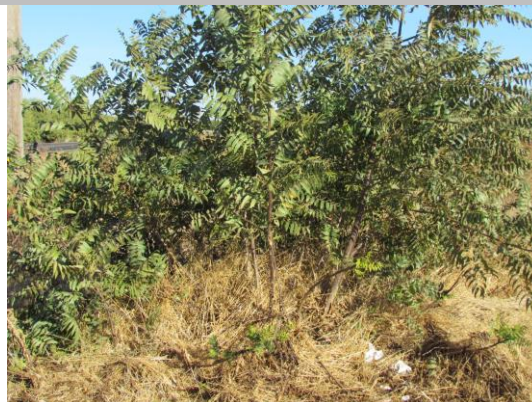
Photo 1 of 1 : FA\_2016\_NA0013\_332\_9\_20161012\_00021.jpg

LM Start	1.63	Rating **	M	Issue No.	9
LM End	1.63	Issue Type +	Ma	Location *	LS
Category	Earthen Levee			GPS Latitude/Longitude	
				Start	End
Item	Encroachments			37.317758 °	37.317758 °
				-120.395750 °	-120.395750 °
DWR ID	DWR_NA0013_02_f_2016_9				
Comment Code					
TR : Tree or limb					
Inspector Comment					
Take out this walnut tree from the landside shoulder.

Unit 2 levee mile 1.63 landside shoulder.

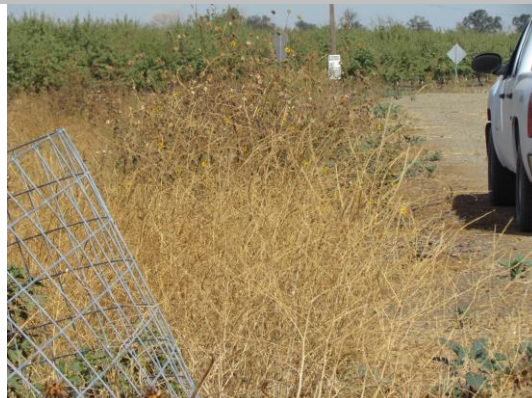
Photo 1 of 1 : FA\_2016\_NA0013\_333\_4\_20161013\_00003.jpg

LM Start	0.40	Rating **	U	Issue No.	4
LM End	0.57	Issue Type +	Ma	Location *	LS
Category	Earthen Levee			GPS Latitude/Longitude	
				Start	End
Item	Vegetation			37.263385 °	37.265792 °
				-120.288345 °	-120.288405 °
DWR ID	DWR_NA0013_03_f_2016_4				
Comment Code					
V1 : Control annual grass and weeds on the levee slopes and easements.					
Inspector Comment					
Remove the Tall dead weed growth from the landside slope and levee toe.

Unit 3 looking upstream landside slope levee mile 0.40-0.57.
